Re: Steelcote Manufacturing Company

Enclosed is a description of corrective actions taken and a schedule for completion of other corrective actions to be taken by Steelcote Manufacturing Company in response to EPA's March 6, 1991 RCRA notice of violation.

Response of Steelcote Manufacturing Company
to March 6, 1991 RCRA Notice of Violation

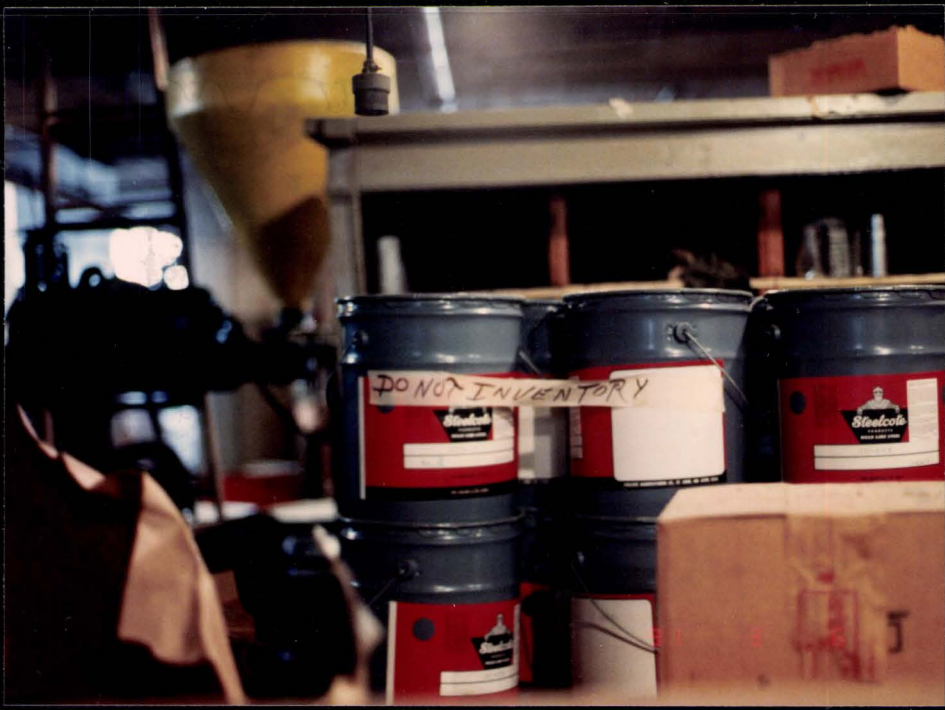
Photo #: 06 Date: 3/6/91
Facility: Steelcote Mfg. Co.
Location: St. Louis, MO Inspector: K. Goschen
Comments: > 90 day storage in generator storage
area - drum label dated 10/26/90

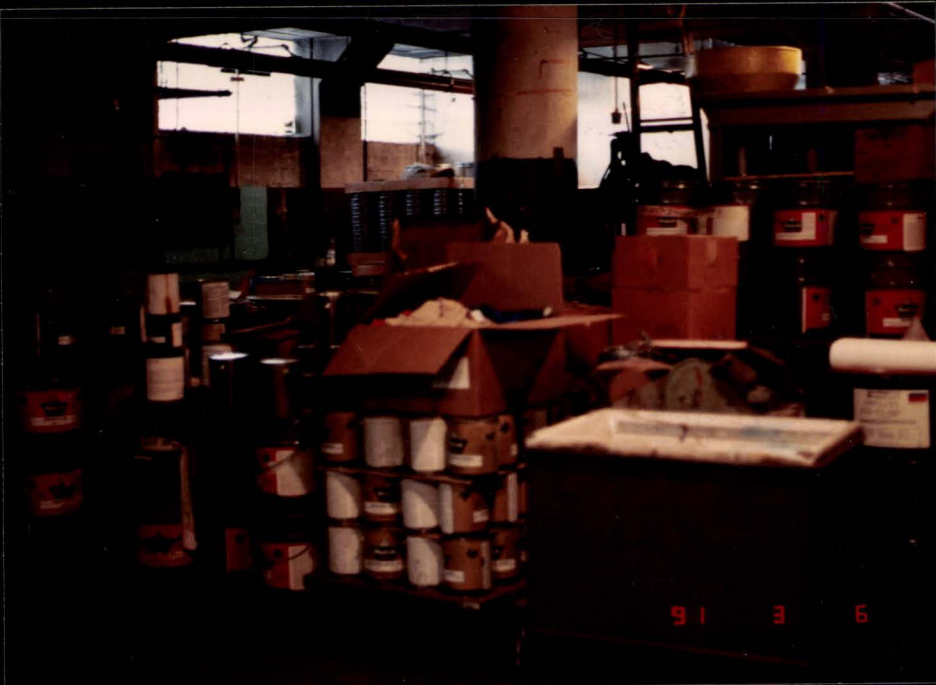
Photo #: 07 Date: 3/6/91
Facility: Steelcote Mfg. Co.
Location: St. Louis, MO Inspector: K. Goschen
Comments: > 90 day storage in generator storage
area - drum label dated 10/10/90

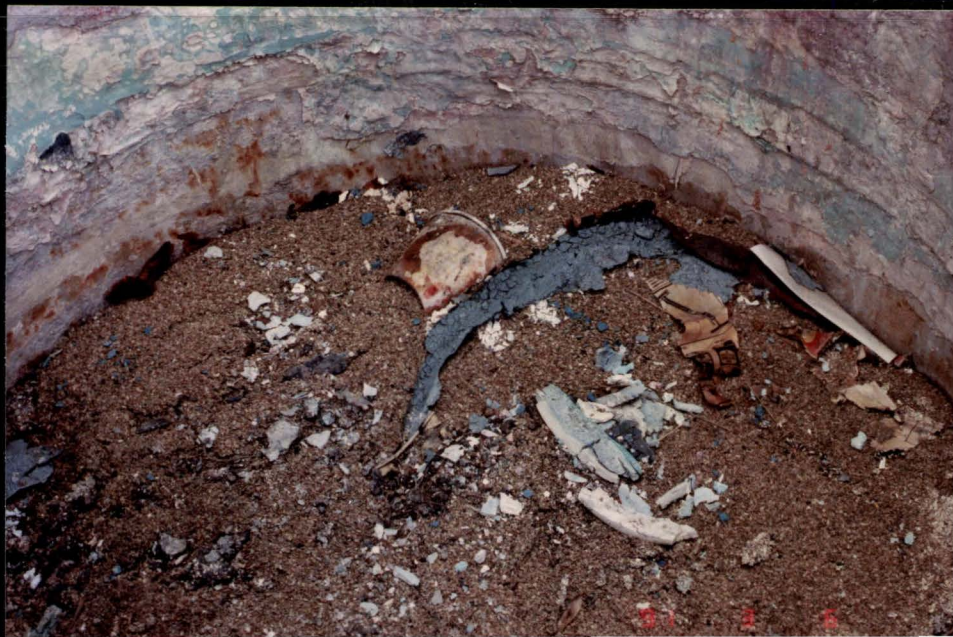
Photo #: 08 Date: 3/6/91
Facility: Steelcote Mfg. Co.
Location: St. Louis, MO Inspector: K. Goschen
Comments: Tanks and mixer containing old roofing
compound

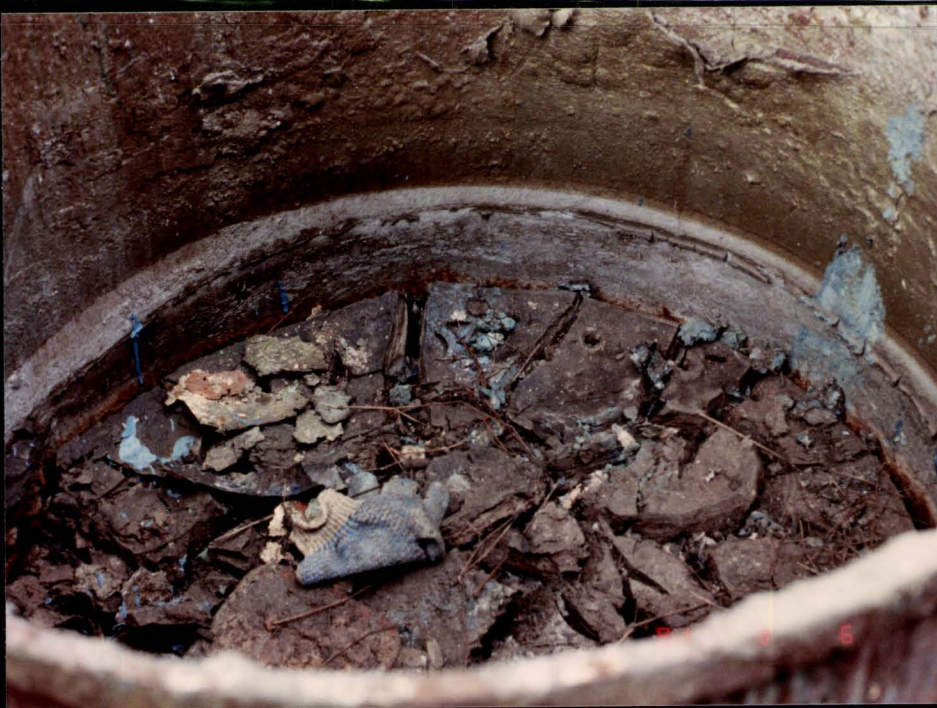
Photo #: 09 Date: 3/6/91
Facility: Steelcote Mfg. Co.
Location: St. Louis, MO Inspector: K. Goschen
Comments: Returned product

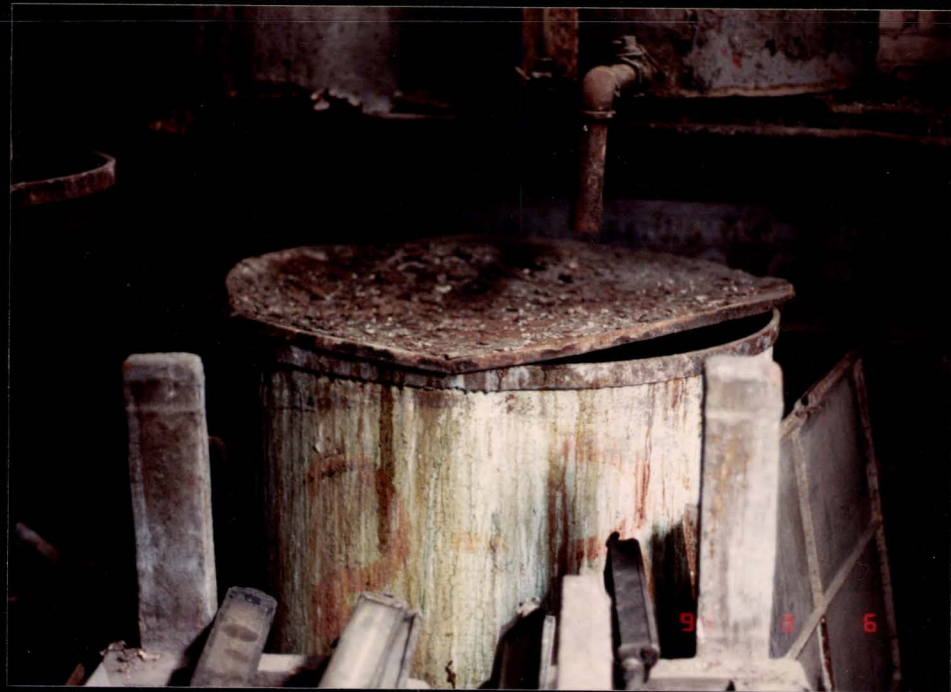
Photo #: 10 Date: 3/6/91
Facility: Steelcote Mfg. Co.
Location: St. Louis, MO Inspector: K. Goschen
Comments: Returned product

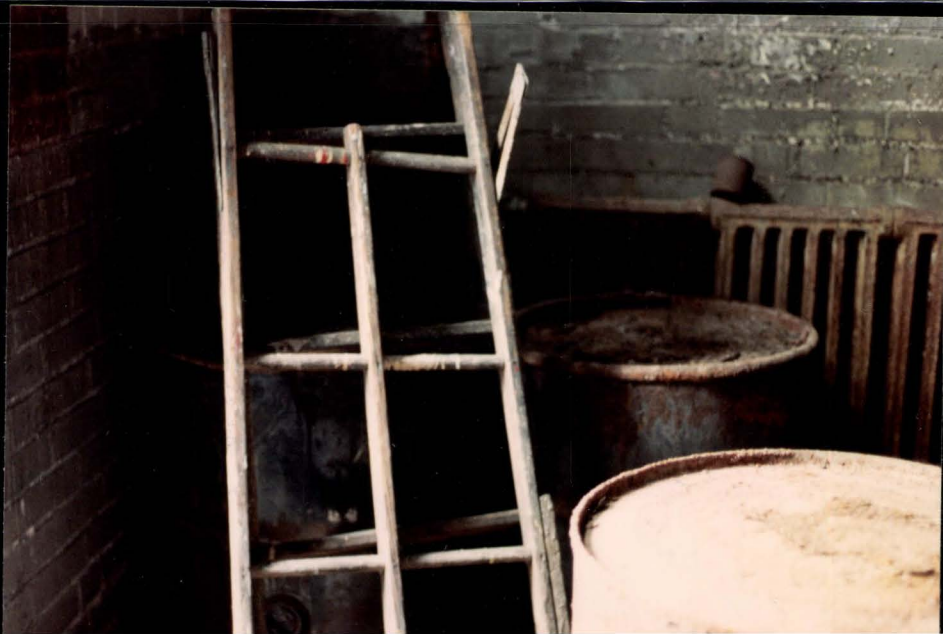
Photo #: 11 Date: 3/6/91
Facility: Steelcote Mfg. Co.
Location: St. Louis, MO Inspector: K. Goschen
Comments: Waste residue in 80-gallon paint
mixing/transfer kettle

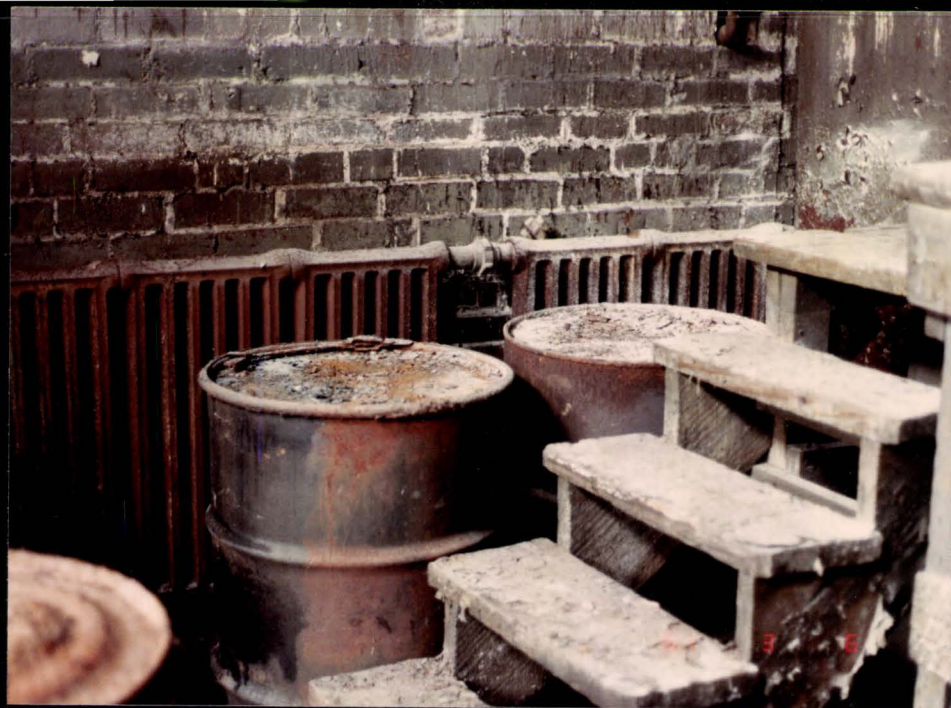
Photo #: 12 Date: 3/6/91
Facility: Steelcote Mfg. Co.
Location: St. Louis, MO Inspector: K. Goschen
Comments: Waste residue in 80-gallon paint
mixing/transfer kettle

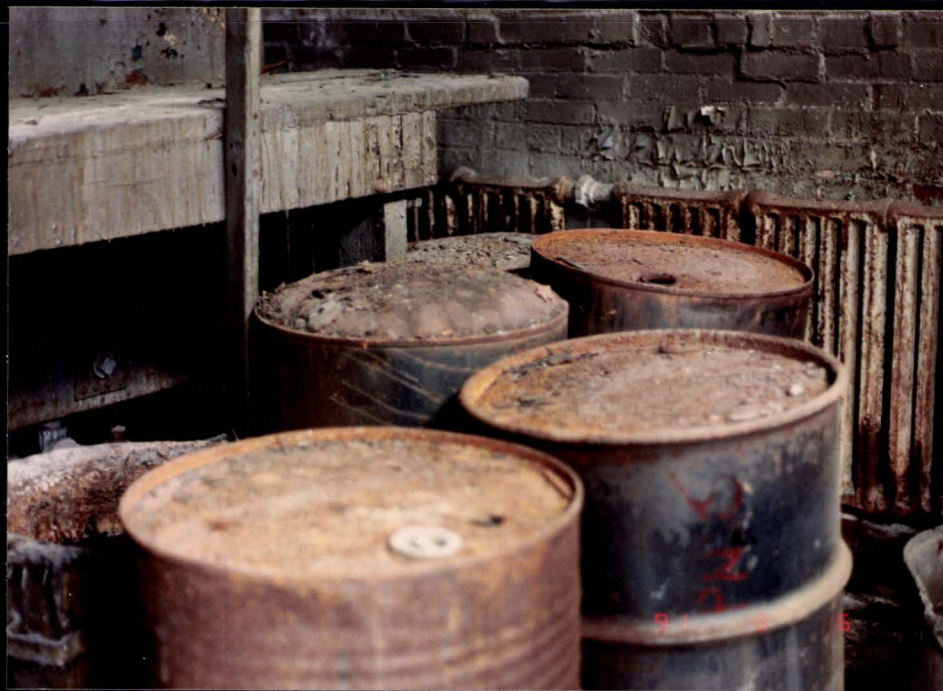
Photo #: 13 Date: 3/6/91
Facility: Steelcote Mfg. Co.
Location: St. Louis, MO Inspector: K. Goschen
Comments: 1/3 full, 80-gallon paint
mixing/transfer kettle in varnish room

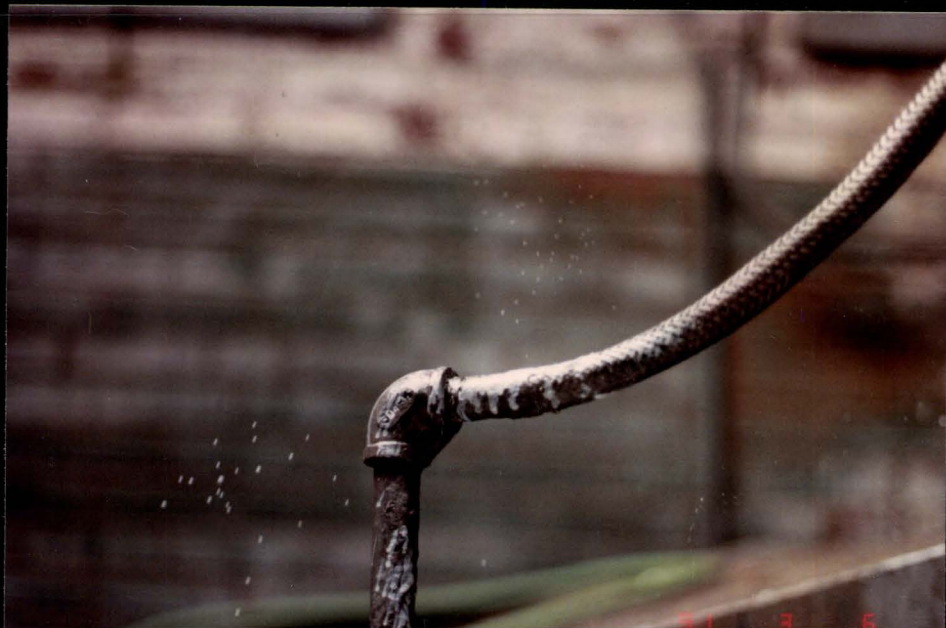
Photo #: 17 Date: 3/6/91
Facility: Steelcote Mfg. Co.
Location: St. Louis, MO Inspector: K. Goschen
Comments: Sprinkler head in outside storage
area

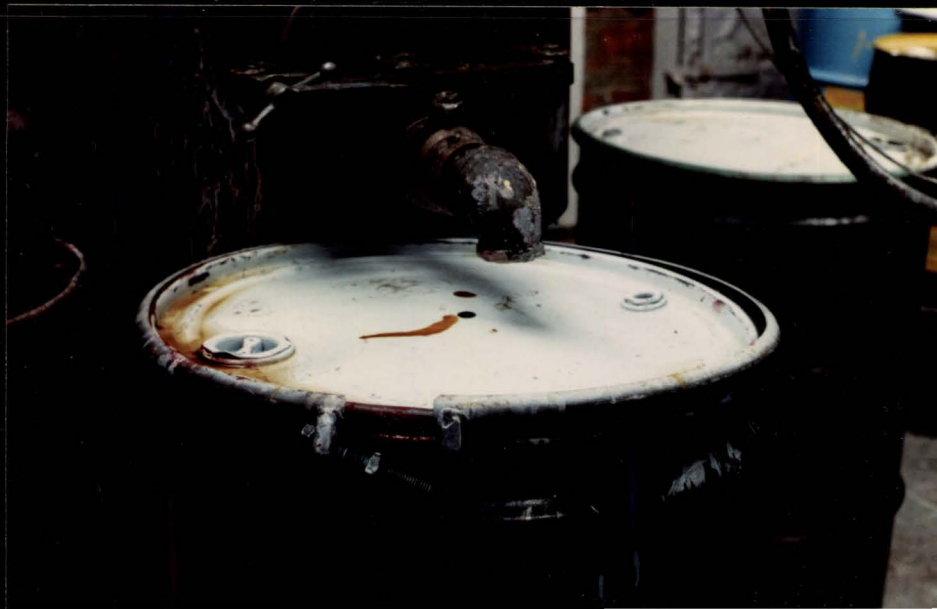
Photo #: 20 Date: 3/6/91
Facility: Steelcote Mfg. Co.
Location: St. Louis, MO Inspector: K. Goschen
Comments: Leak in still feed line
(note small droplets)

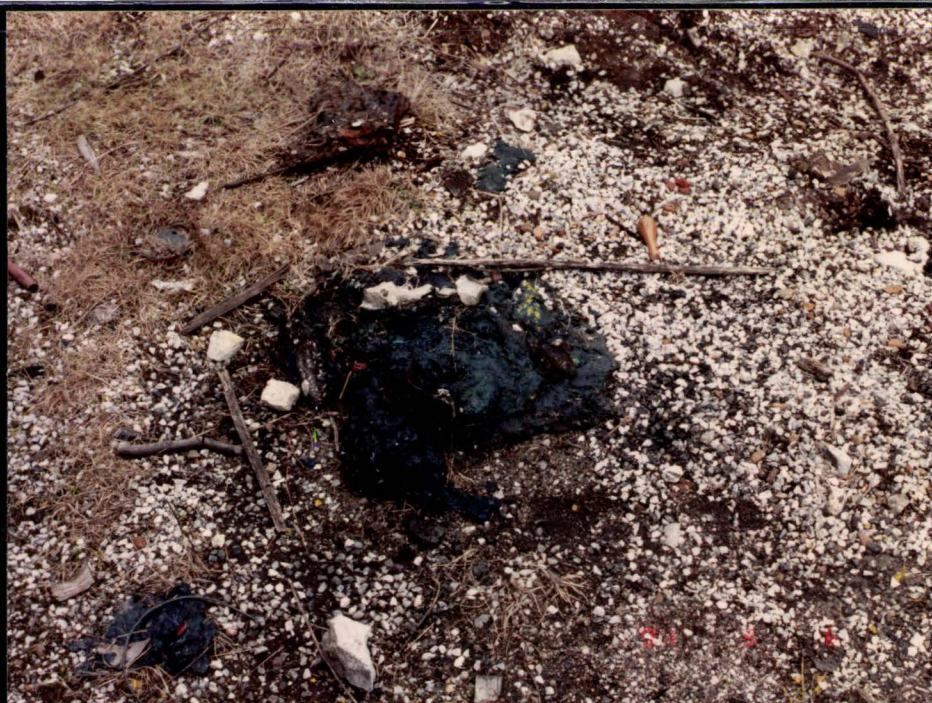
Photo #: 24 Date: 3/6/91
Facility: Steelcote Mfg. Co.
Location: St. Louis, MO Inspector: K. Goschen
Comments: Open hole in still room which shows
evidence of past spills

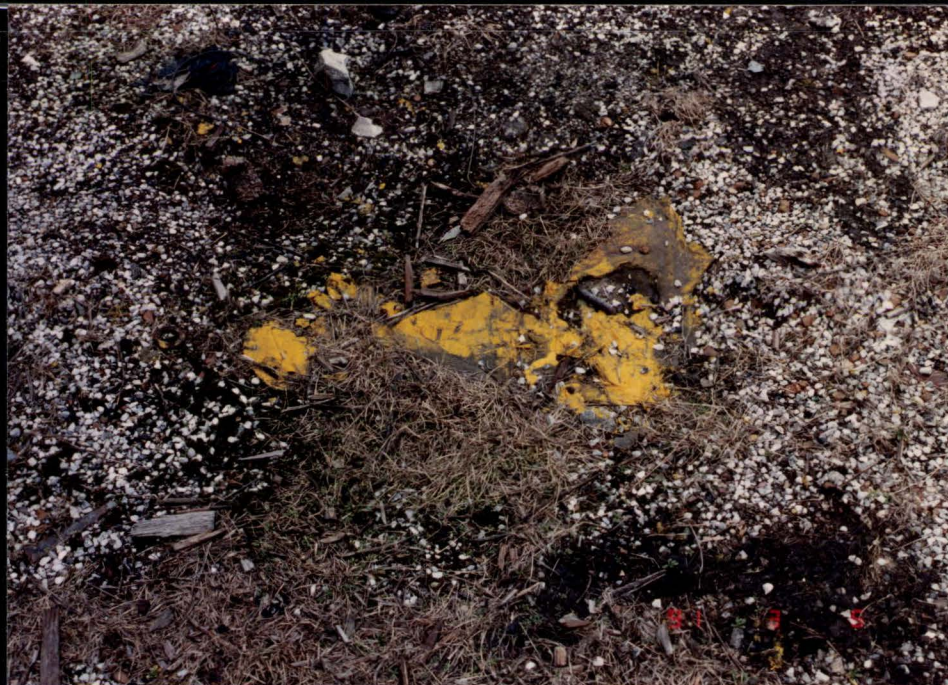
Photo #: 25 Date: 3/6/91
Facility: Steelcote Mfg. Co.
Location: St. Louis, MO Inspector: K. Goschen
Comments: Dumped/open drum of paint and other
manufacturing wastes in courtyard

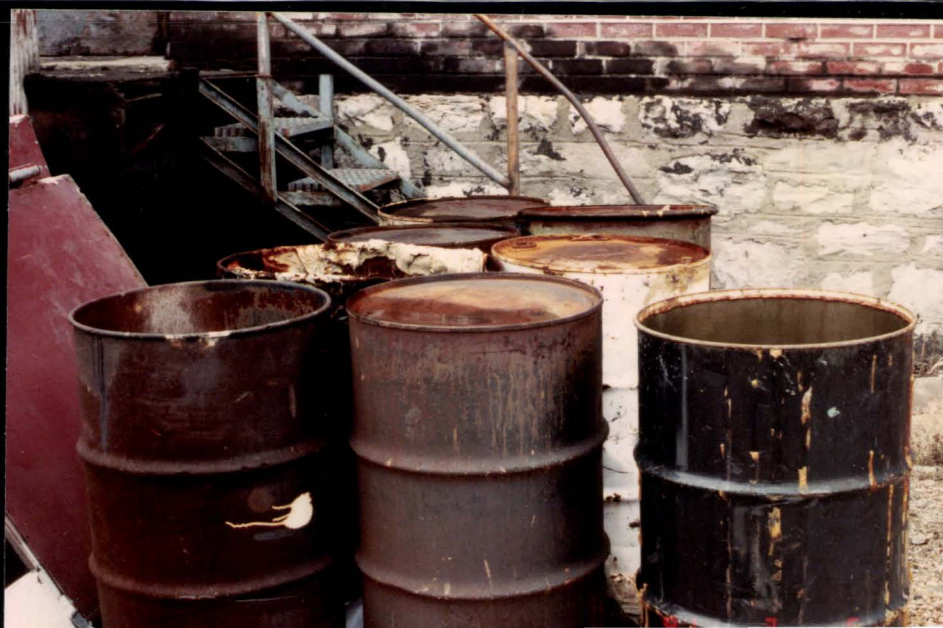
Photo #: 26 Date: 3/6/91
Facility: Steelcote Mfg. Co.
Location: St. Louis, MO Inspector: K. Goschen
Comments: Dumped/open drum of paint and other
manufacturing wastes in courtyard

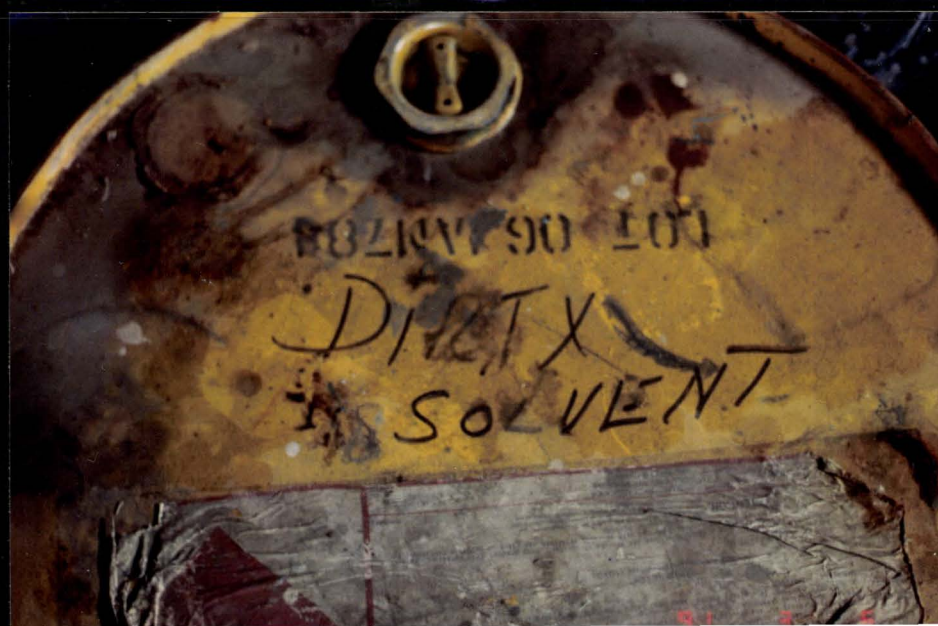
Photo #: 29 Date: 3/6/91
Facility: Steelcote Mfg. Co.
Location: St. Louis, MO Inspector: K. Goschen
Comments: Drums of unknowns in courtyard

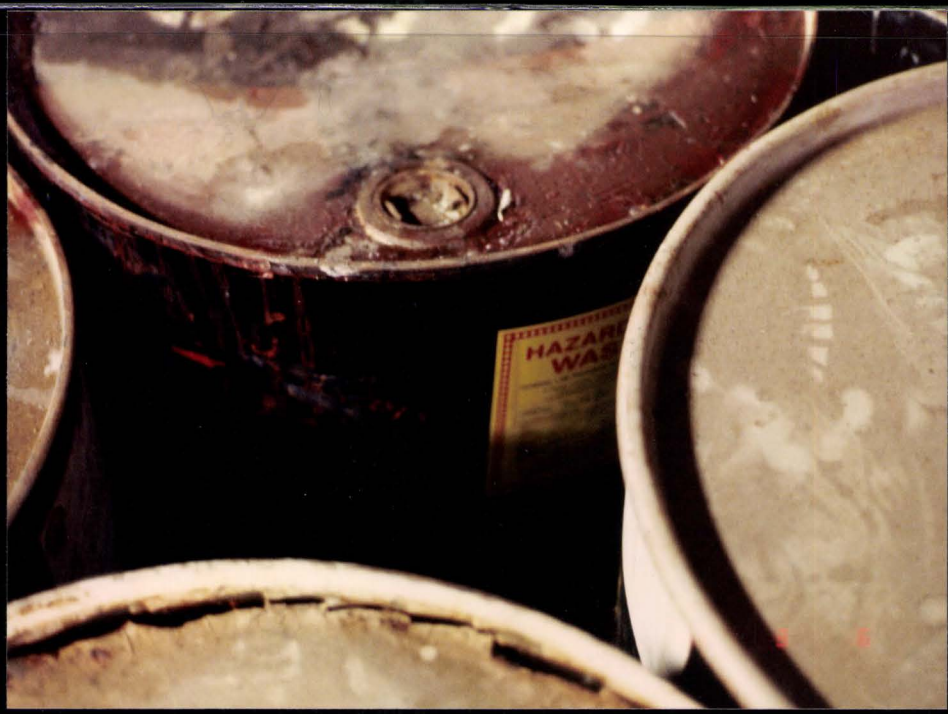
Photo #: 30 Date: 3/6/91
Facility: Steelcote Mfg. Co.
Location: St. Louis, MO Inspector: K. Goschen
Comments: Tanks on west side of tin shed,
contents unknown

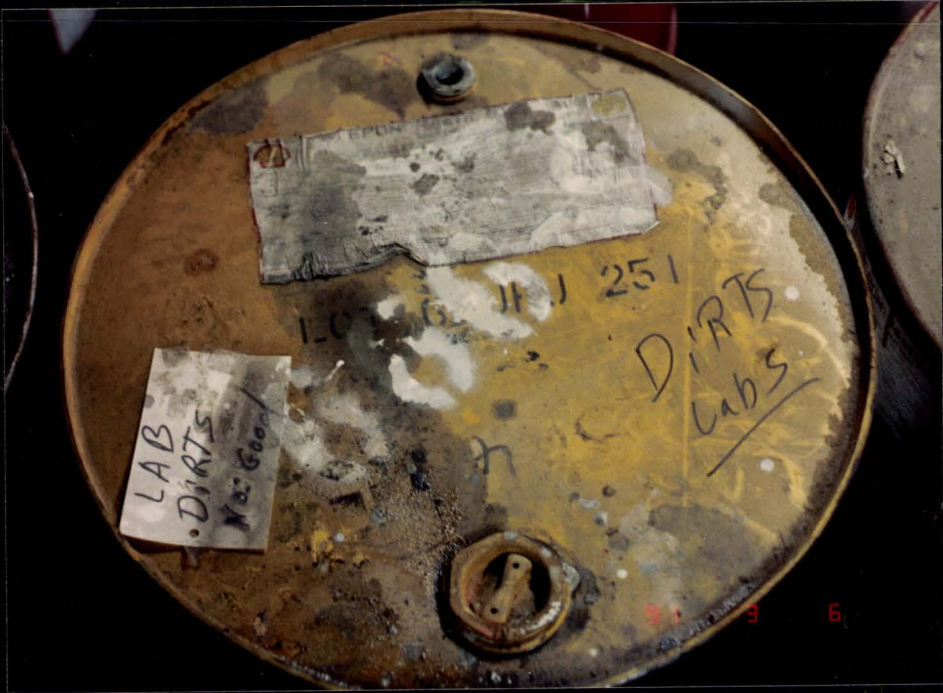
Photo #: 31 Date: 3/6/91
Facility: Steelcote Mfg. Co.
Location: St. Louis, MO Inspector: K. Goschen
Comments: Approximately 100 drums of unknowns in
tin shed

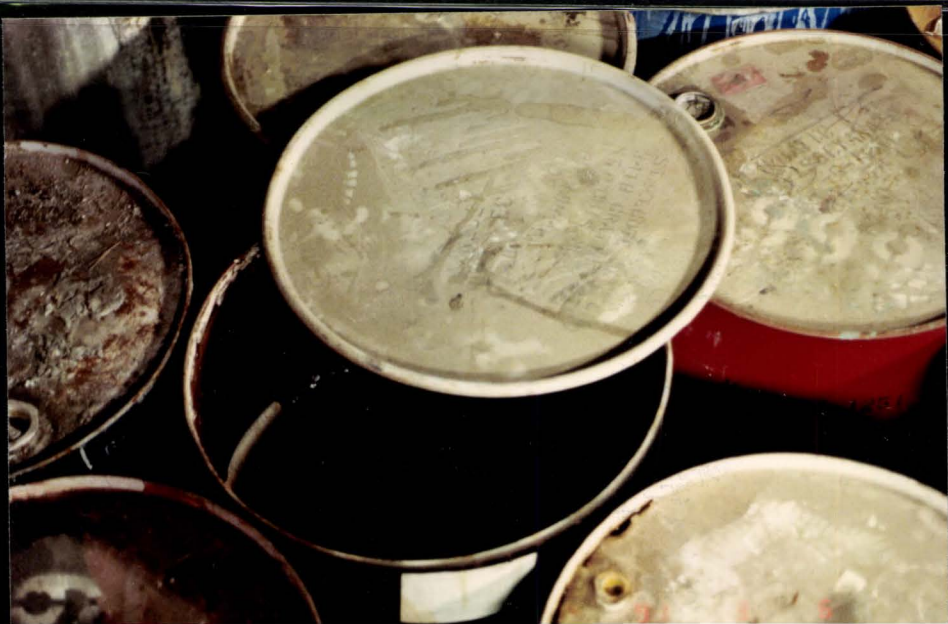
Photo #: 35 Date: 3/6/91
Facility: Steelcote Mfg. Co.
Location: St. Louis, MO Inspector: K. Goschen
Comments: One of approximately 100 drums
in tin shed - this one labeled hazardous waste

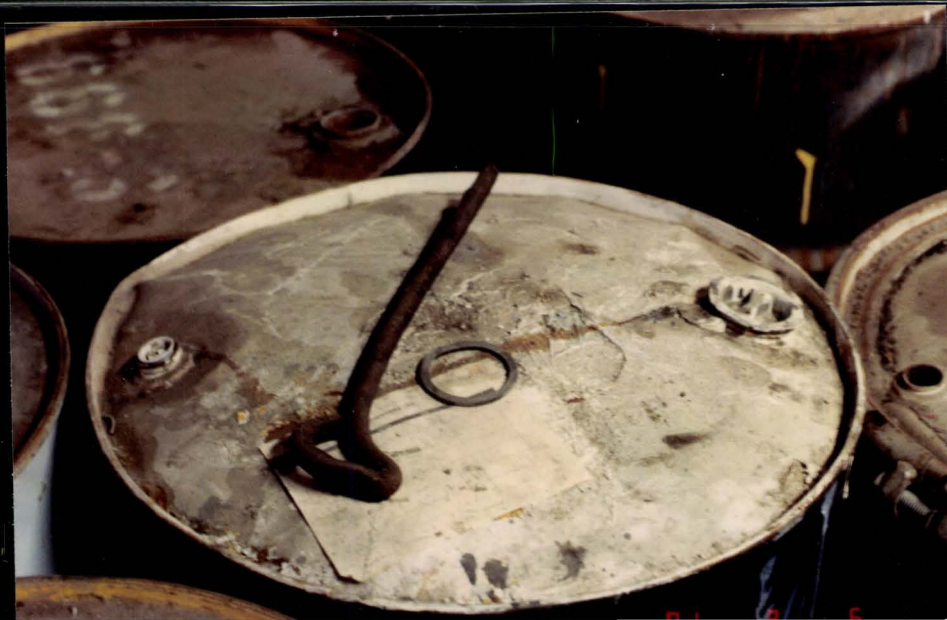
36A
Photo #: 36 Date: 3/6/91
Facility: Steelcote Mfg. Co.
Location: St. Louis, MO Inspector: K. Goschen
Comments: One of approximately 100 drums
in tin shed - this one labeled as hard

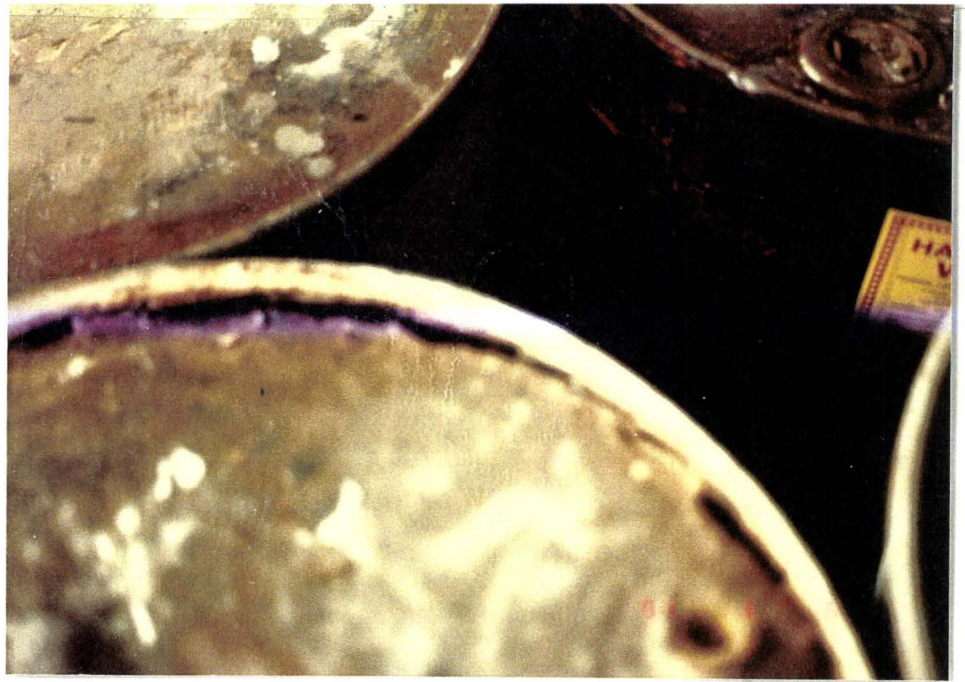
Photo #: 38 Date: 3/6/91
Facility: Steelcote Mfg. Co.
Location: St. Louis, MO Inspector: K. Goschen
Comments: One of approximately 100 drums
in tin shed - this one in poor condition

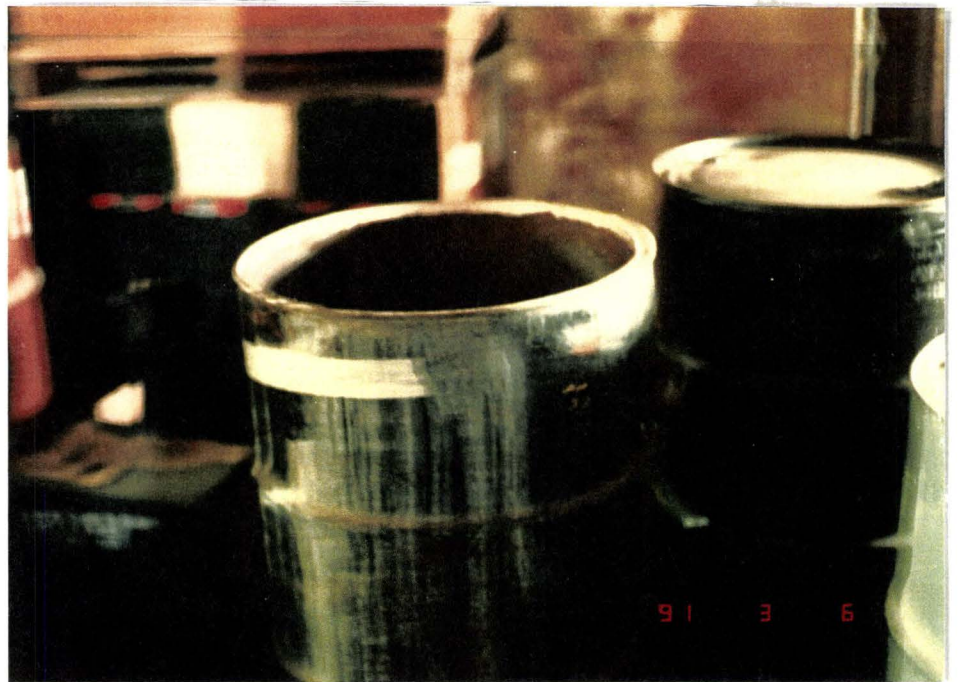
Photo #: 39 Date: 3/6/91
Facility: Steelcote Mfg. Co.
Location: St. Louis, MO Inspector: K. Goschen
Comments: One of approximately 100 drums
in tin shed - this one in poor condition

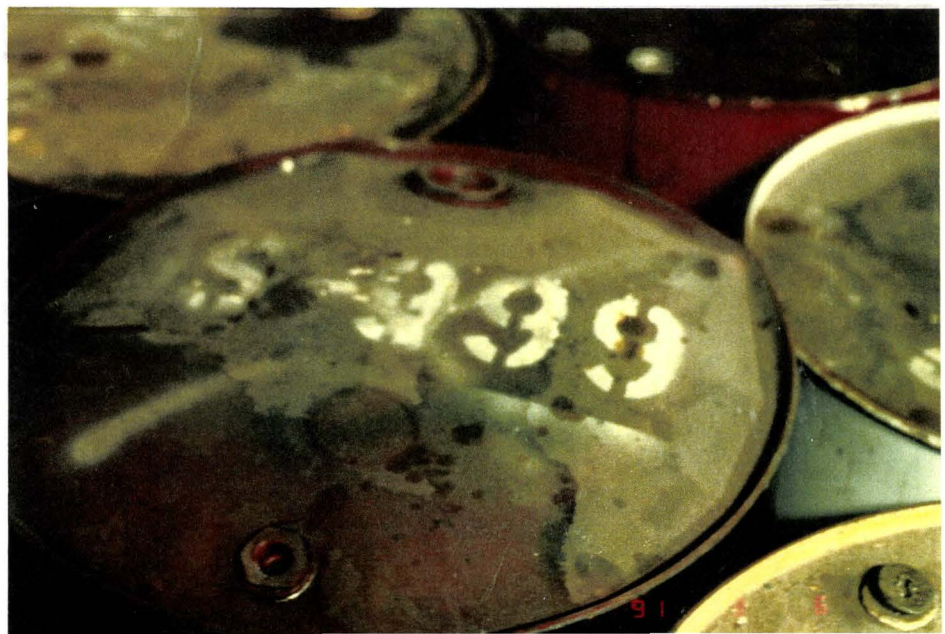
Photo #: 40 Date: 3/6/91
Facility: Steelcote Mfg. Co.
Location: St. Louis, MO Inspector: K. Goschen
Comments: One of approximately 100 drums
in tin shed - this one in poor condition

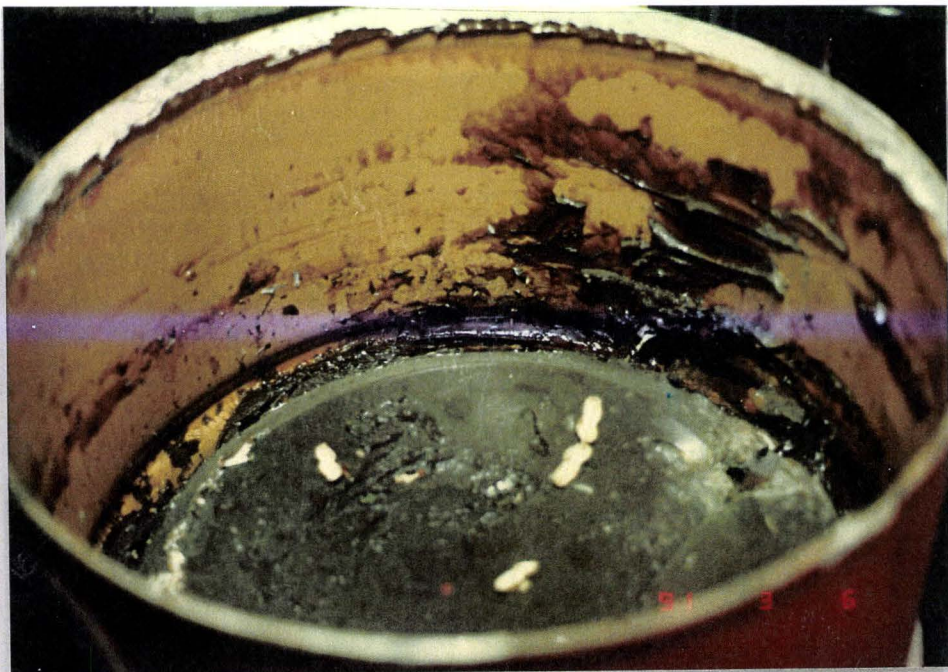
Photo #: 41 Date: 3/6/91
Facility: Steelcote Mfg. Co.
Location: St. Louis, MO Inspector: K. Goschen
Comments: One of approximately 100 drums
in tin shed - this one in open condition,
note opened edge

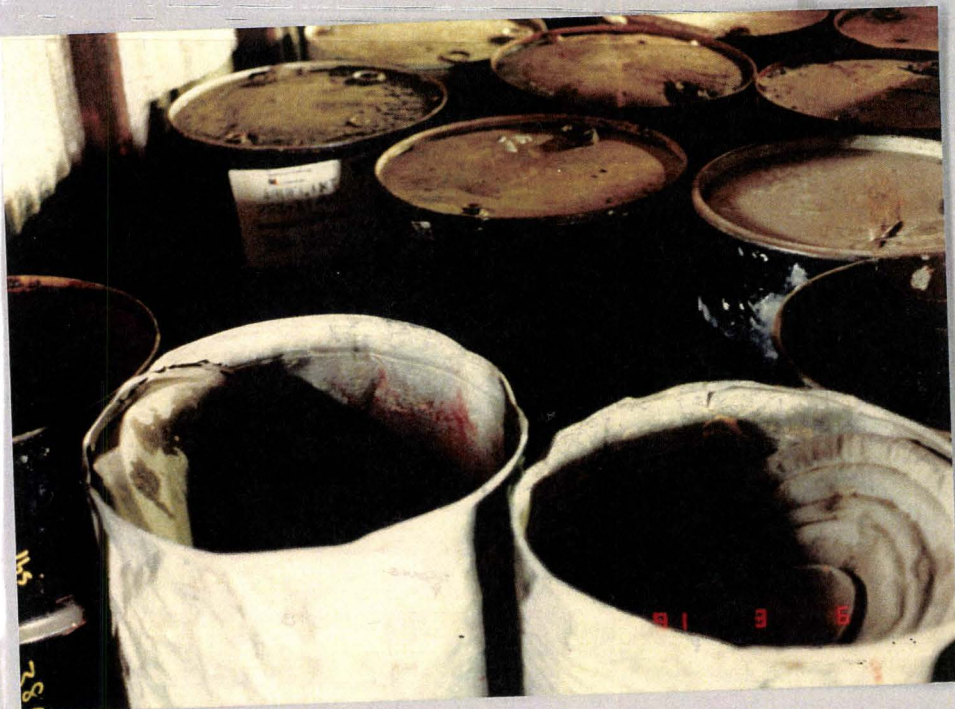
Photo #: 42 Date: 3/6/91
Facility: Steelcote Mfg. Co.
Location: St. Louis, MO Inspector: K. Goschen
Comments: One of approximately 100 drums
in tin shed - open

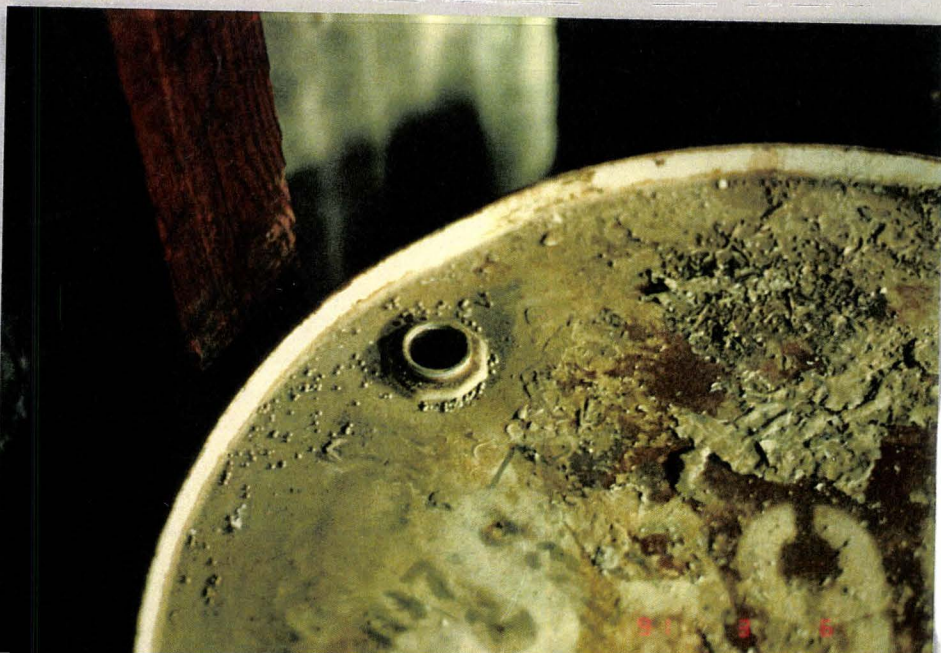
Photo #: 43 Date: 3/6/91
Facility: Steelcote Mfg. Co.
Location: St. Louis, MO Inspector: K. Goschen
Comments: One of approximately 100 drums
in tin shed - this one in poor condition

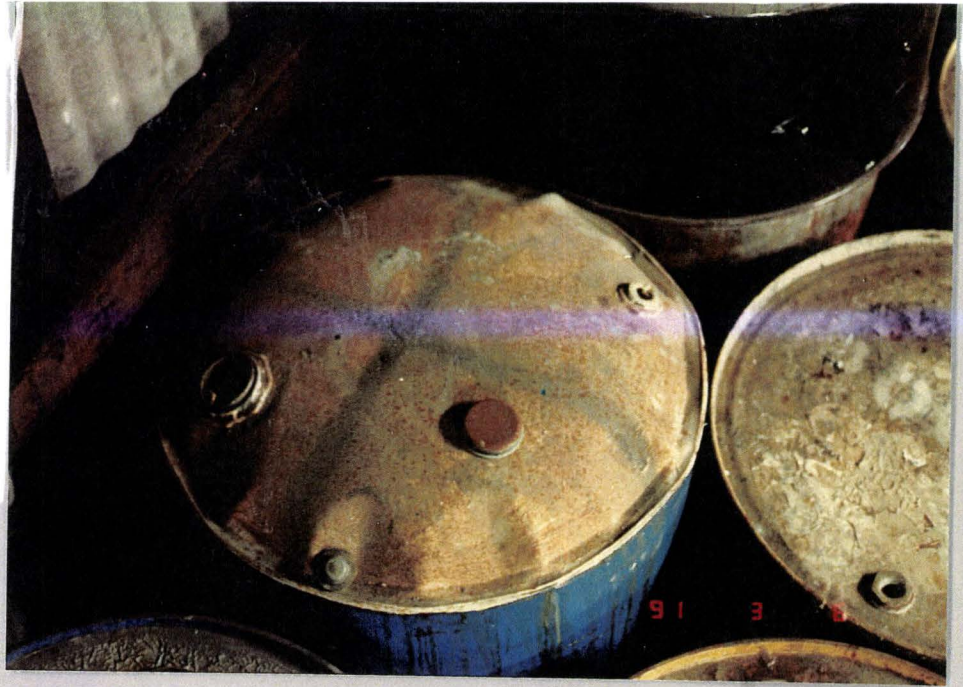
Photo #: 44 Date: 3/6/91
Facility: Steelcote Mfg. Co.
Location: St. Louis, MO Inspector: K. Goschen
Comments: One of approximately 100 drums
in tin shed - this one was open

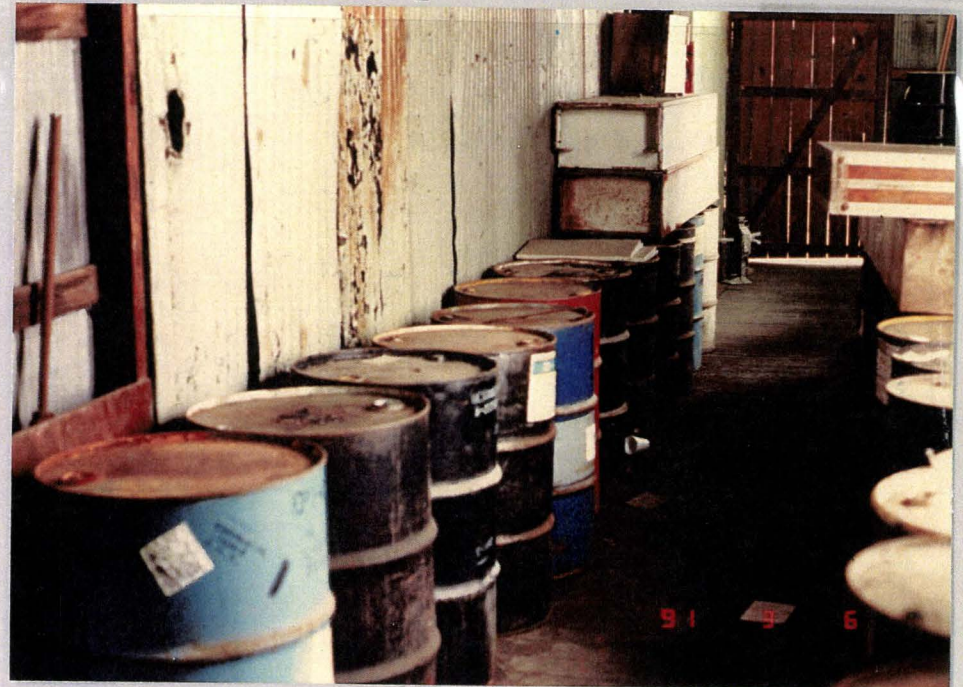
Photo #: 45 Date: 3/6/91
Facility: Steelcote Mfg. Co.
Location: St. Louis, MO Inspector: K. Goschen
Comments: Four of approximately 100 drums
in tin shed - these four were open

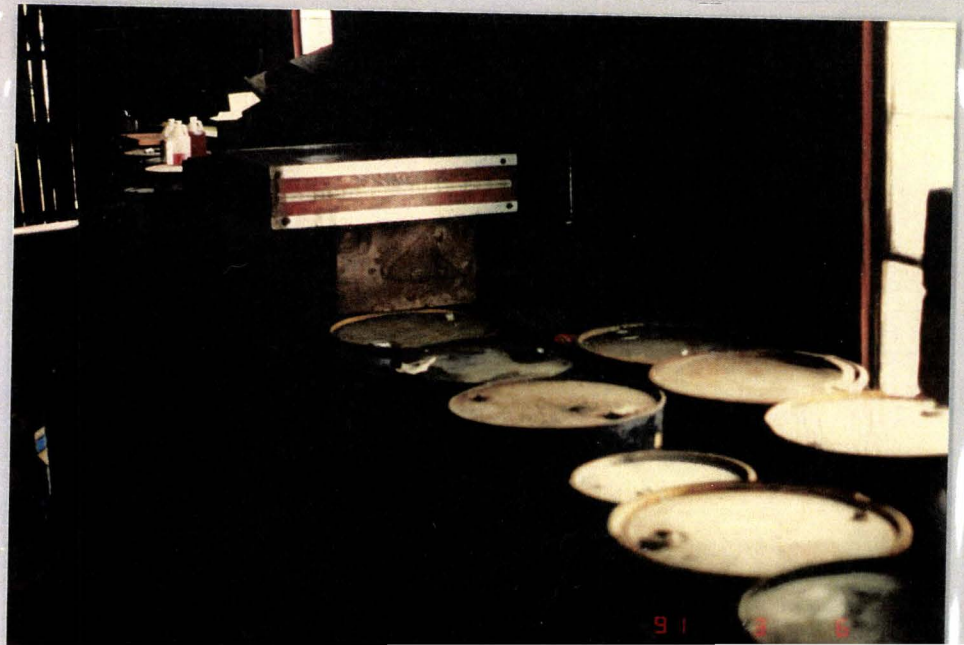
Photo #: 46 Date: 3/6/91
Facility: Steelcote Mfg. Co.
Location: St. Louis, MO Inspector: K. Goschen
Comments: One of approximately 100 drums
in tin shed - this one was open

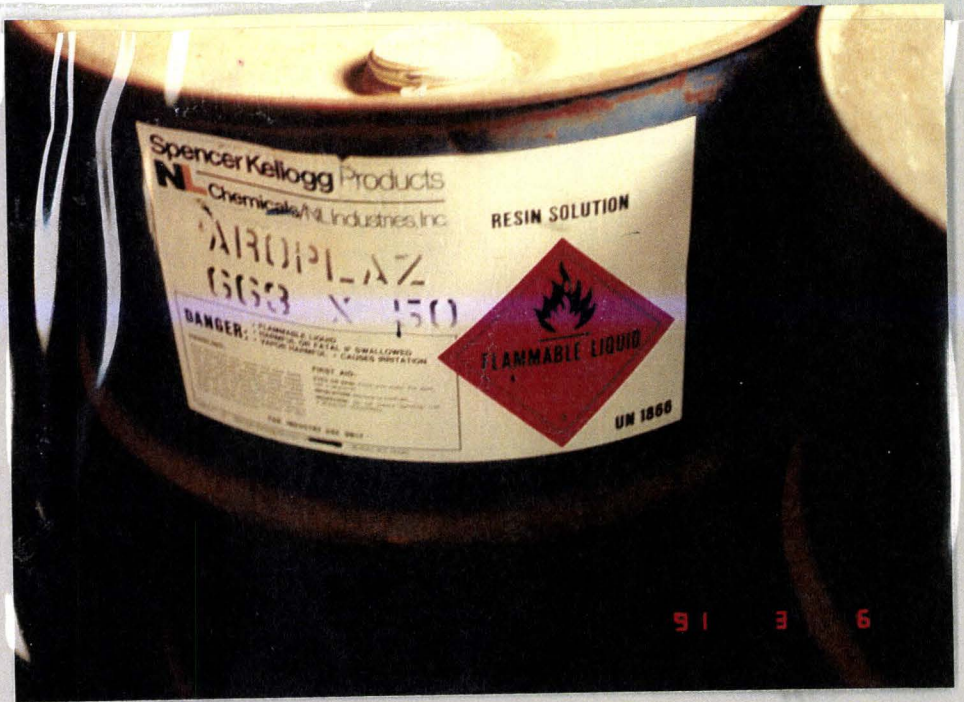
Photo #: 47 Date: 3/6/91
Facility: Steelcote Mfg. Co.
Location: St. Louis, MO Inspector: K. Goschen
Comments: One of approximately 100 drums
in tin shed - this one in poor condition

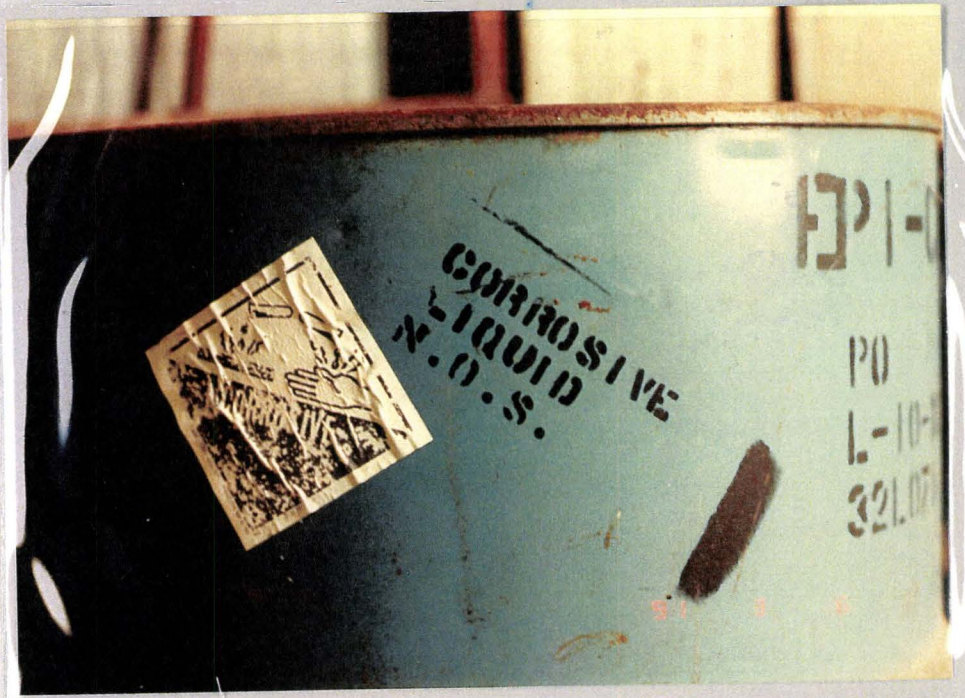
Photo #: 48 Date: 3/6/91
Facility: Steelcote Mfg. Co.
Location: St. Louis, MO Inspector: K. Goschen
Comments: Approximately 50 drums on south side
of tin shed

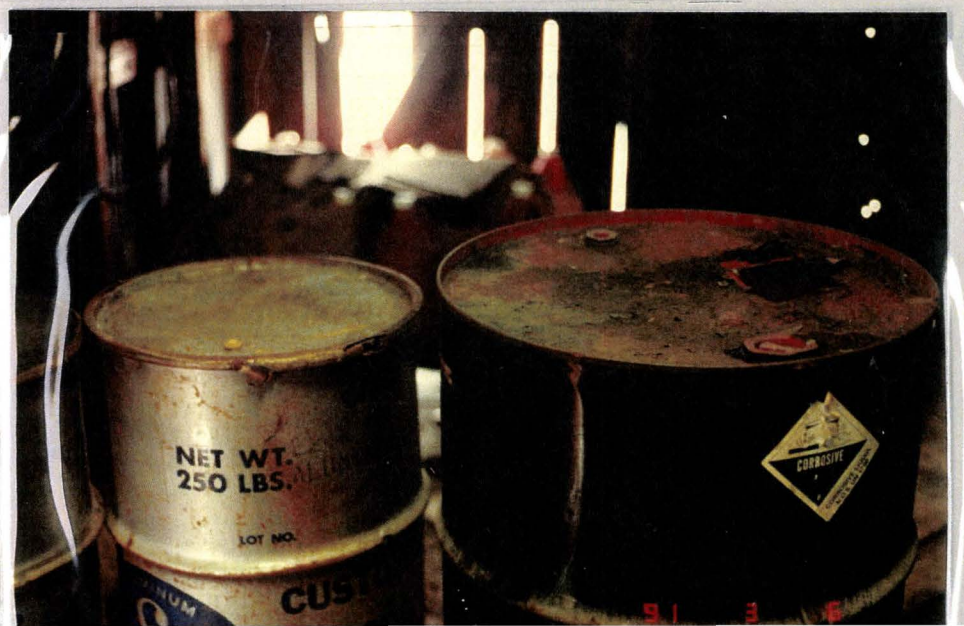
Photo #: 49 Date: 3/6/91
Facility: Steelcote Mfg. Co.
Location: St. Louis, MO Inspector: K. Goschen
Comments: Approximately 50 drums on the
south side of the tin shed
